River Bank Erosion and Restoration in the Brahmaputra River in India

Abstract: The complex and unique riverbank erosion characteristics of the Brahmaputra River in India, the fourth largest river in the world in terms of average discharge at the mouth and second only to the Yellow River in China in the amount of sediment transported per unit drainage area, is highlighted with illustrations of the severity of erosion caused at various bank locations. First, the source and the entire course of the river are described. Riverbank erosion mechanisms and existing erosion control measures and their effectiveness in the Assam reach of the Brahmaputra River are described. As part of a joint effort for the first time between U.S. and Indian (local) investigators to understand and find solutions to this mega unique problem of the Brahmaputra River, a set of recommendations, including a phase-wise multiple solutions to the acute and potential riverbank erosion sites along this large river, is forwarded for discussion and getting feed back from international experts.

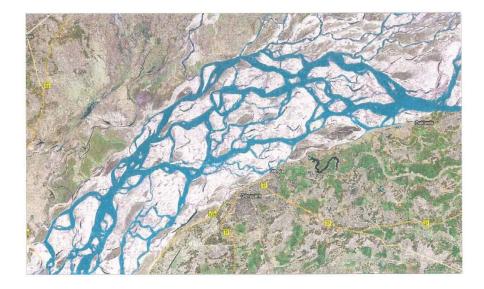
Figure 2. Braided channels of the Brahmaputra near Dibrugarh, Assam (http://maps.google.com/)

A longitudinal bank profile of the Brahmaputra presented in Goswami (1985) reveals that the river has a gradient of 0.09 to 0.17 m/km near Dibrugarh, Assam at the head of the Valley and it is reduces to about 0.1 m/km near Guwahati. Through Assam, the long term average discharge increases from 8,500 to 17,000 cubic meters per second as flows are augmented by major tributaries. The width of the river varies from one km on an individual channel to as much as 10 km in some reaches with multiple braided channels. Almost through its entire length in Assam, the river has three to six channels separated by islands and mid-channel bars under low flow conditions. These bars and islands become submerged during major floods. The pattern of channels changes frequently under flood conditions accompanied by extensive erosion of banks and disposition of sediment forming sand bars. Figure 2 presents a typical braiding in the Brahmaputra River.

comprised of numerous sand bars and islands (Figure 2). Beginning in May as the flow begins to rise, raising its stage (water depth) in response to high runoff from the monsoon precipitation, most of the bars as well as islands get submerged. Coleman (1969) noted that the most striking feature of the change in channel configuration of the Brahmaputra is the continuous shift of the thalweg from one location to another within the bank lines of the river. He reported that the movement of the thalweg is high during the rising stages (May through June), relatively less during the peak of the flood (July through August), most erratic during the receding stages (September through October) and very little during the low flow stages (November through March). Goswami (1985) described that the sediment transport is high during the rising stage marking aggradation of the channel while the falling trend marked by low sediment transport indicating degradation of the channel. The shifting of thalweg in relation to river flow pattern with the sediment transport and the changing of the channel configuration causes serious bank erosion of the river.

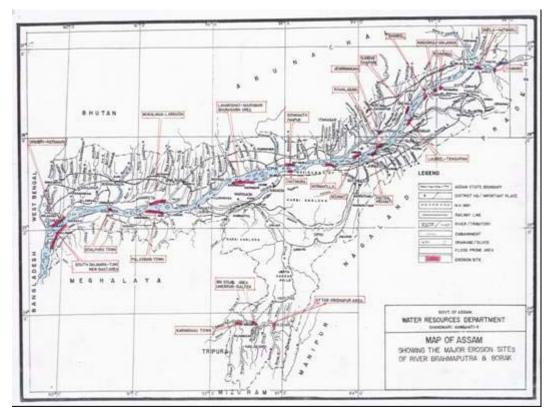
Figure 3. Locations of Severe Bank Erosion in the Brahmaputra River in Assam (WRD, 2008)

The Water Resources Department (WRD, 2008), Government of Assam, India has identified twenty five (25) such vulnerable and severe river bank erosion sites (Figure 3). Bank erosion rates and affected households at five of those sites are presented in Table 1.

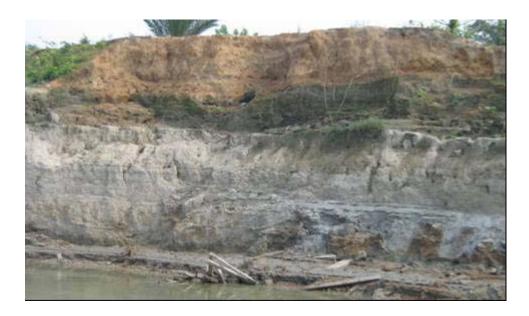
Figure 4. River Bank Failure of the Brahmaputra River at Palasbari, Assam

The fine sand and silty nature of the river bank material and the unstable bank line along the most part of the river create a highly favorable environment for bank erosion. Bank failures are composed of violent actions of the flowing water and the weak geotechnical properties of the bank materials (Thorne and John, 1979; Pizzuto and ASCE, 2007). The bank formation and rate of recession are controlled by the fluvial processes, whereas the mechanism of bank failure is determined by the engineering properties of the soils. Shear failures in the upper bank materials appear to be by far the most widespread mode of bank failure. This may be caused either by undercutting the upper bank materials by strong currents during the high flows or by over steepening of the bank slopes. Overhanging cantilevered blocks are produced during the undercutting which leads to eventual falls and over steepening causes steep slopes due to migration of thalweg closer to the bank during the falling stages (Coleman, 1969). The bank materials in the Brahmaputra are highly susceptible to erosion by the river due to their high moisture content, low clay content and poorly graded fine sand and silt. Photographs of typical river bank failures at selected locations of the Brahmaputra River are presented in Figures 4-6.

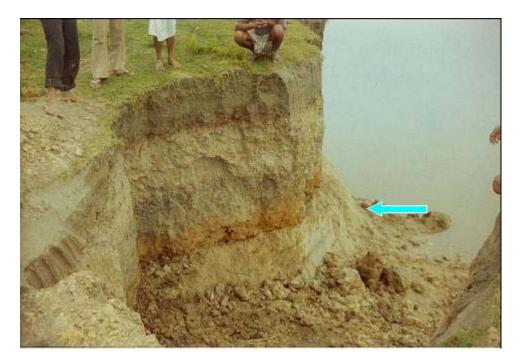
Figure 5. River Bank Failure of the Brahmaputra River at Rohmori, Assam

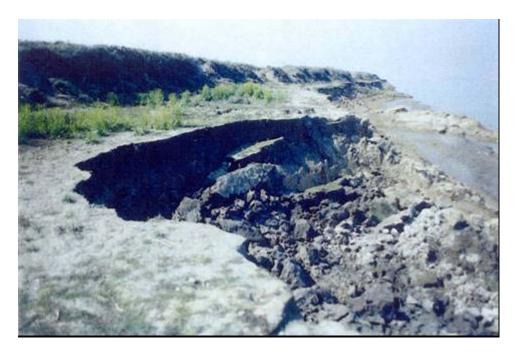
Figure 6. River Bank Failure of the Brahmaputra River at Neamatighat, Jorhat District, Assam
